## **GGOzone** Whirlpool Sanitation System

## 1 Balboa Ozone automatic sanitation systems

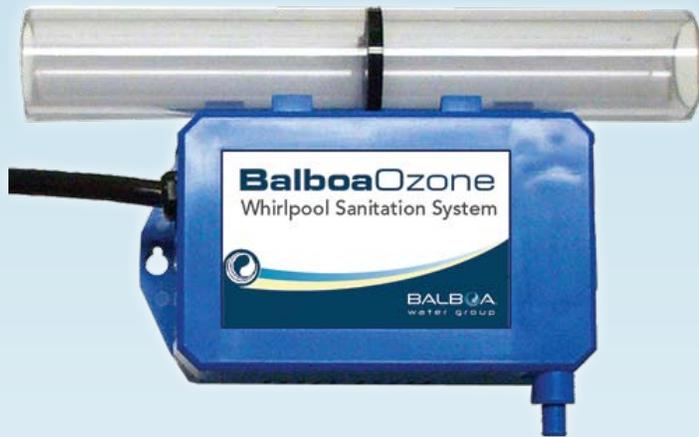
When the tub circulation pump is turned on, the system begins operating in unison. Ozone gas is generated and immediately mixed into the recirculating bath water via the connection between the generator and a dedicated Ozone therapy jet. When the tub pump is turned off, the ozone generator circuit also turns off.

The Ozone manufactured Corona Discharge (CD) generator splits Oxygen O<sub>2</sub> molecules into separate O<sub>1</sub> atoms. The O<sub>1</sub> atoms immediately bond loosely to adjacent O<sub>2</sub> molecules to form powerful O<sub>3</sub> ozone molecules.
